DEPARTMENT OF TRANSPORTATION

Quality Assurance and Source Inspection

Contract #: 04-0120F4Cty: SF/ALA Rte: 80 PM: 13.2/13.9File #: 70.28**WELDING INSPECTION REPORT****Resident Engineer:**Pursell, Gary**Address:** 333 Burma Road**City:** Oakland, CA 94607**Report No:** WIR-004560**Date Inspected:** 07-Nov-2008**Project Name:** SAS Superstructure**OSM Arrival Time:** 800**Prime Contractor:** American Bridge/Fluor Enterprises, a JV**OSM Departure Time:** 1400**Contractor:** Japan Steel Works**Location:** Muroran, Japan**CWI Name:** Chung Fu-Kuan**CWI Present:** Yes No**Inspected CWI report:** Yes No N/A**Rod Oven in Use:** Yes No N/A**Electrode to specification:** Yes No N/A**Weld Procedures Followed:** Yes No N/A**Qualified Welders:** Yes No N/A**Verified Joint Fit-up:** Yes No N/A**Approved Drawings:** Yes No N/A**Approved WPS:** Yes No N/A**Delayed / Cancelled:** Yes No N/A**Bridge No:** 34-0006**Component:** Tower, Deviation and Jacking Saddles**Summary of Items Observed:**

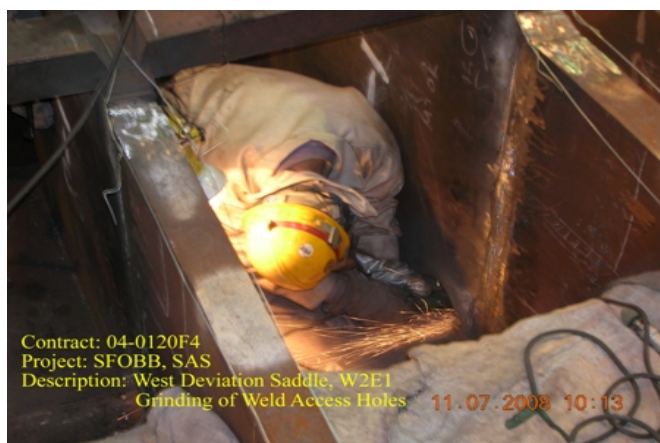
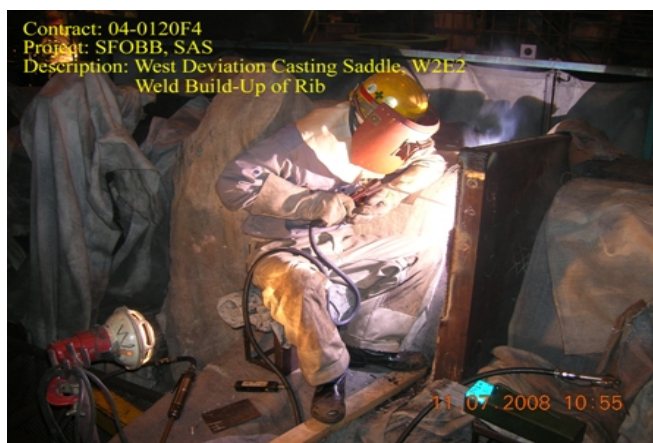
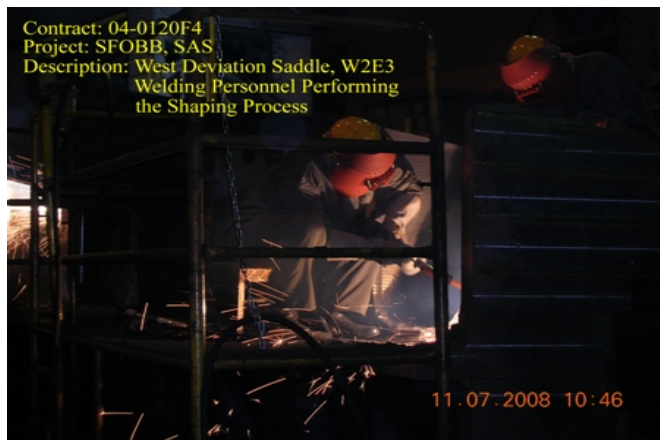
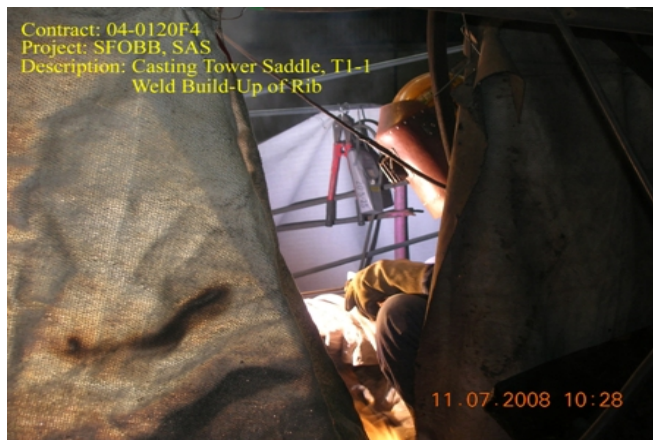
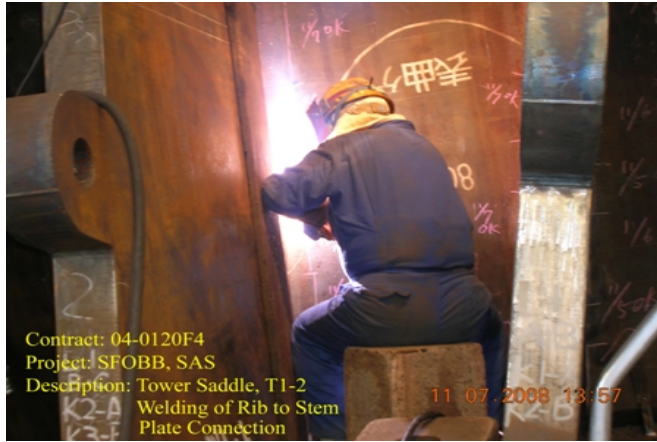
See Weld Joints in Progress Inspected on page 4 of this report in regards to QA observation of the welding parameters recorded during this shift and the following digital photographs and on page 4 of this report which illustrates the observations of the activities performed on this date.
